Cavity Wall Insulation The Hidden Problem

Speaker: Adrian Blythe - Quality Improvement
Manager Northern Ireland Housing Executive

NHMF
Maintenance
Conference
2020

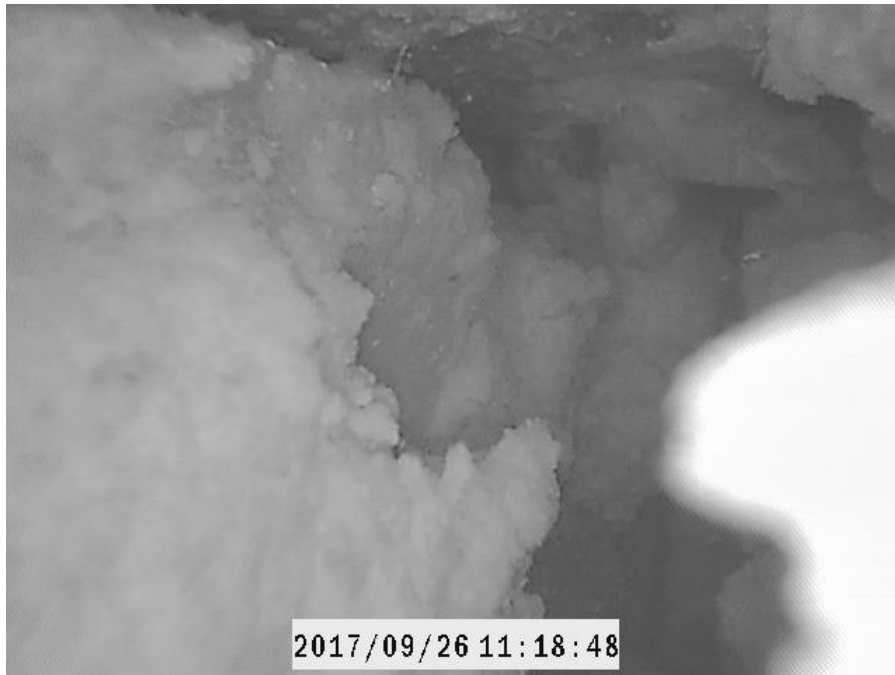
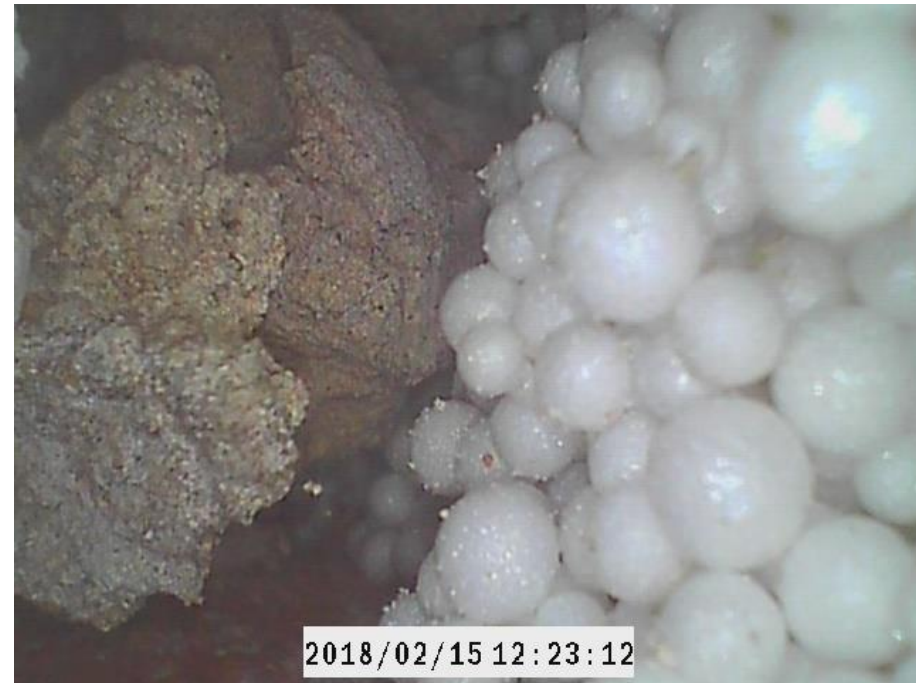
Non-compliant CWI

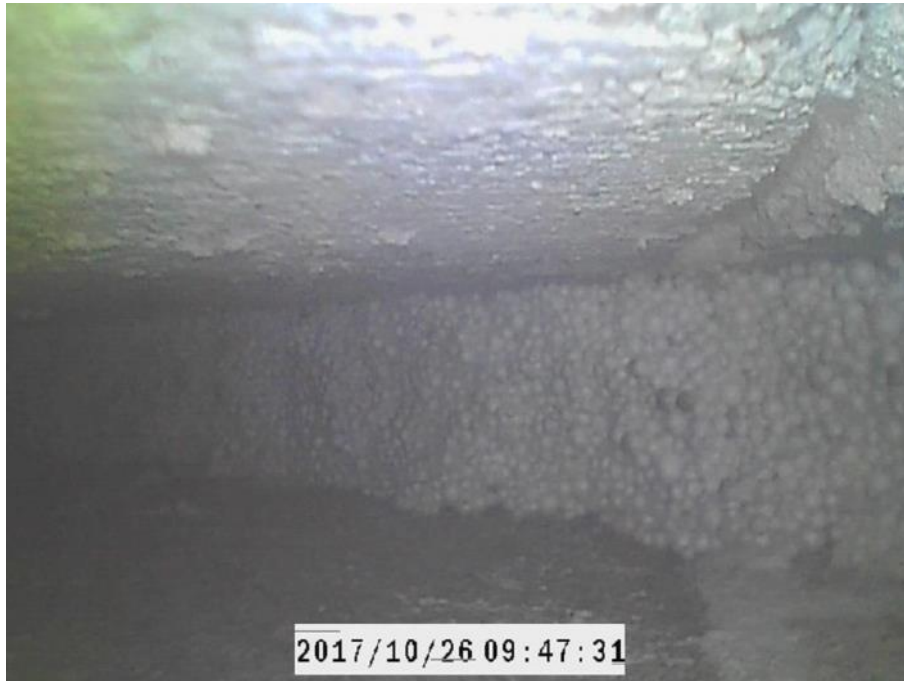
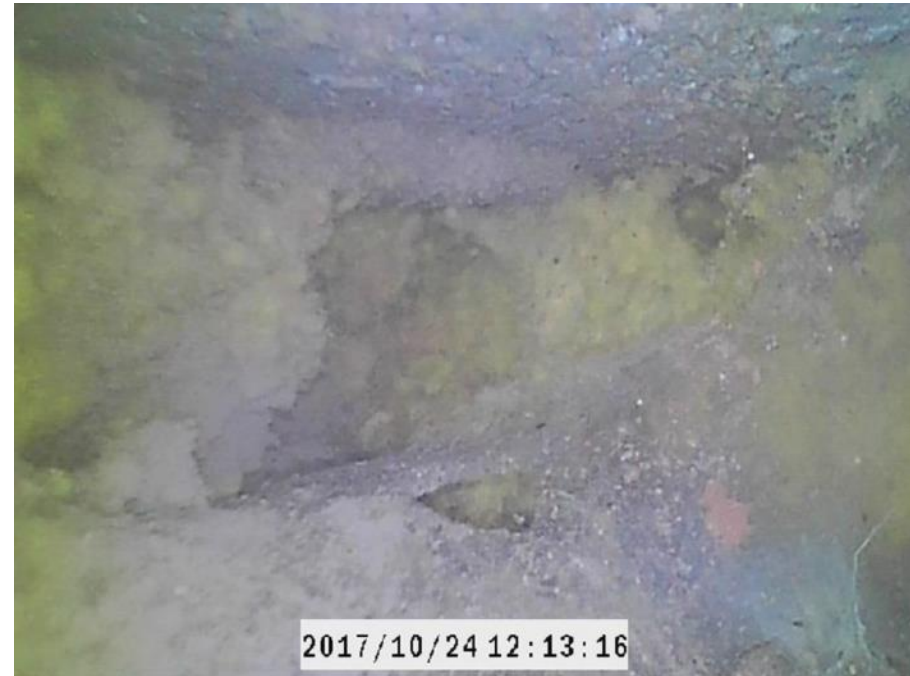
Non-compliant CWI

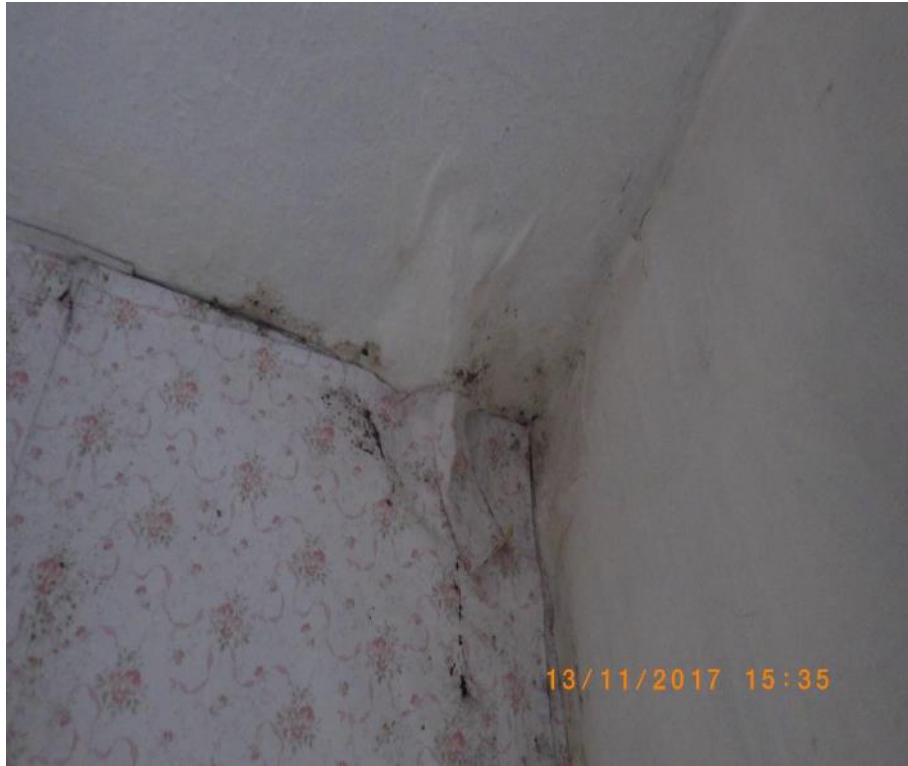
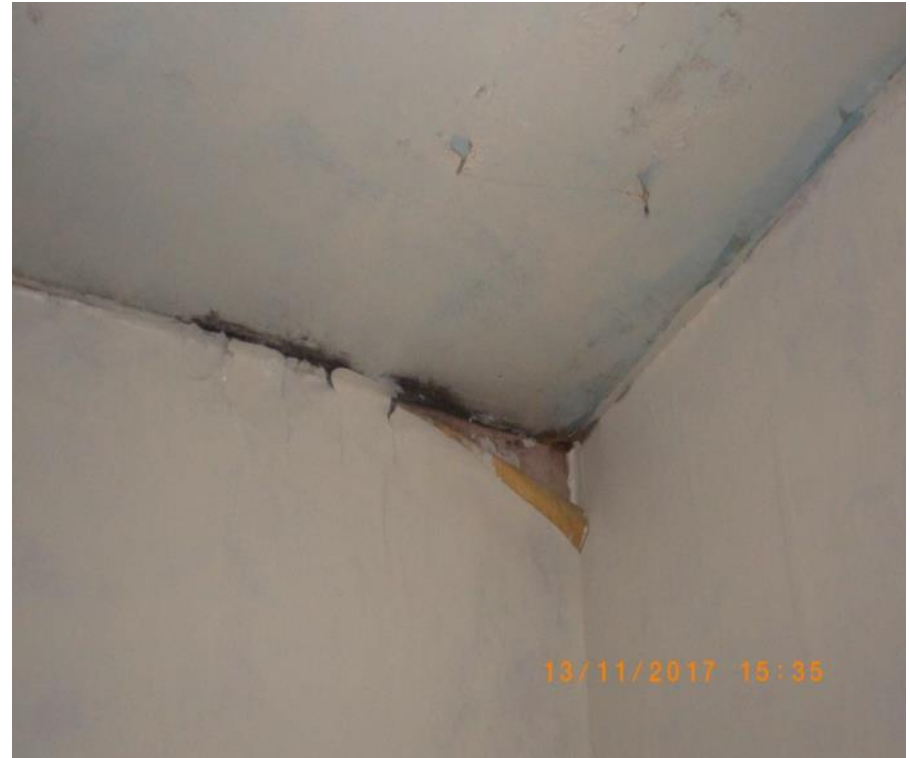
Damp & Condensation

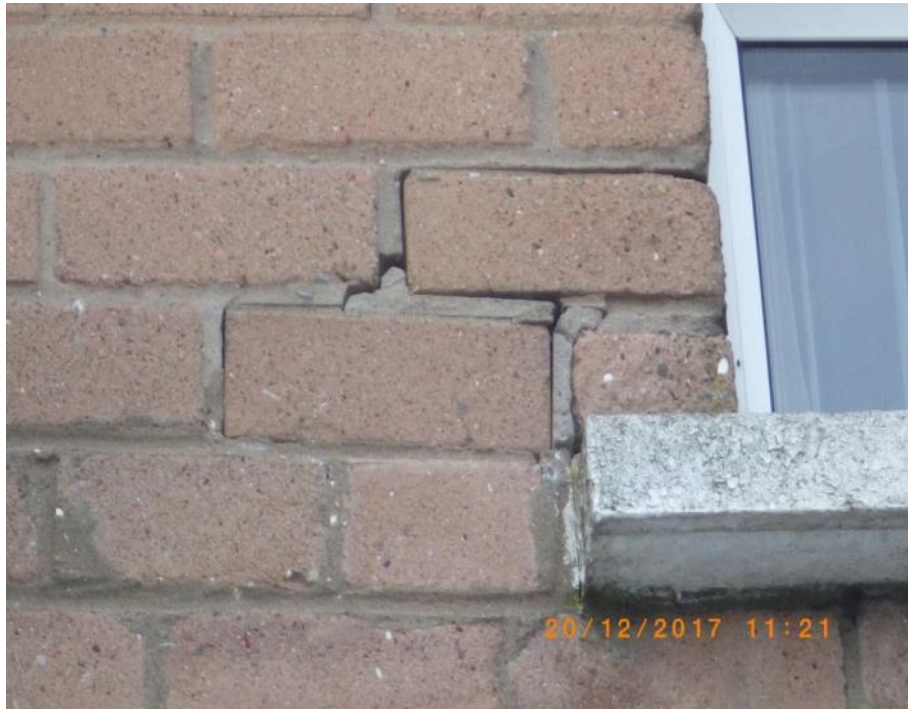
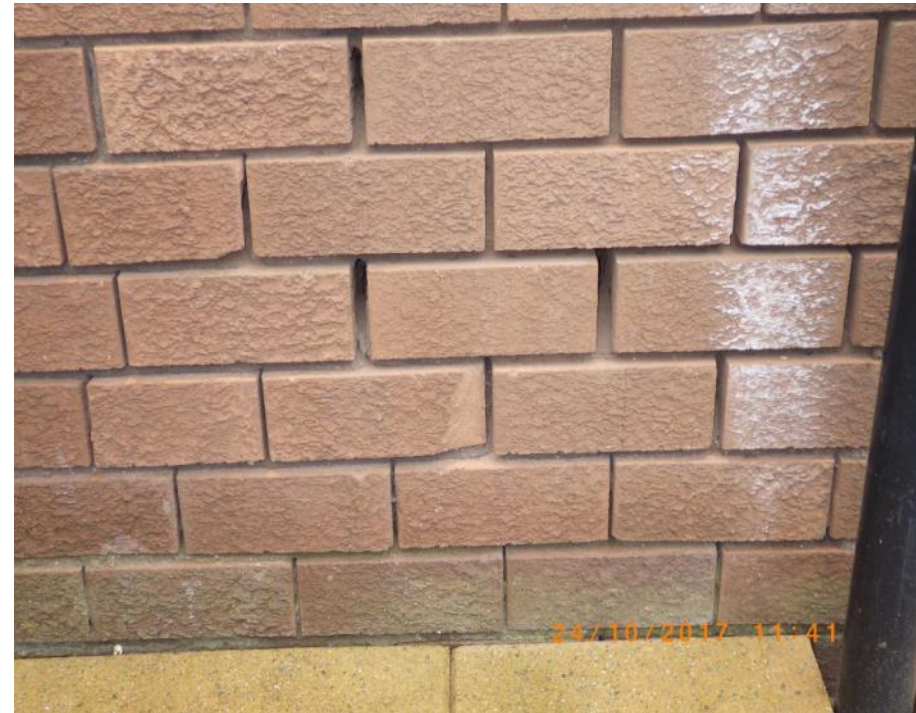
Mortar & Pointing

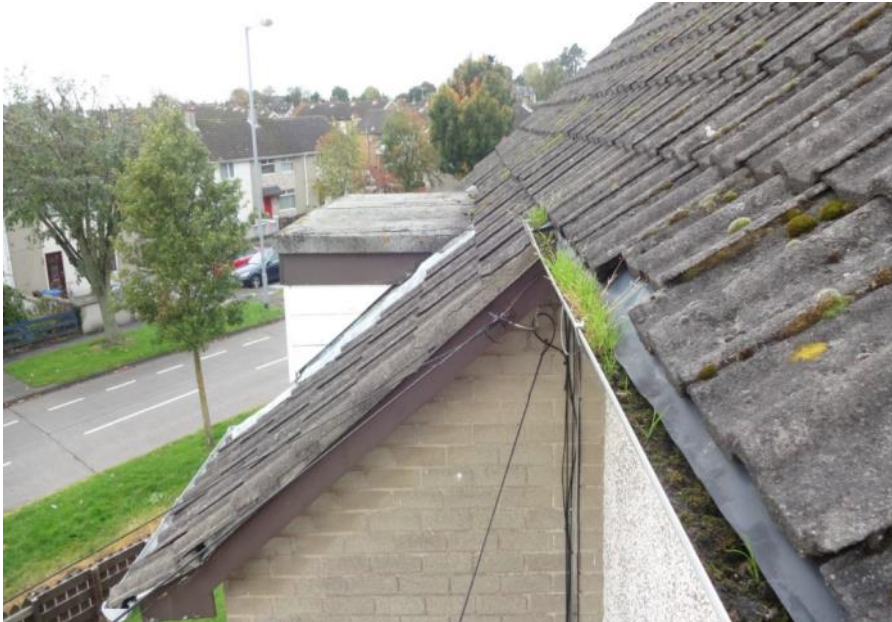
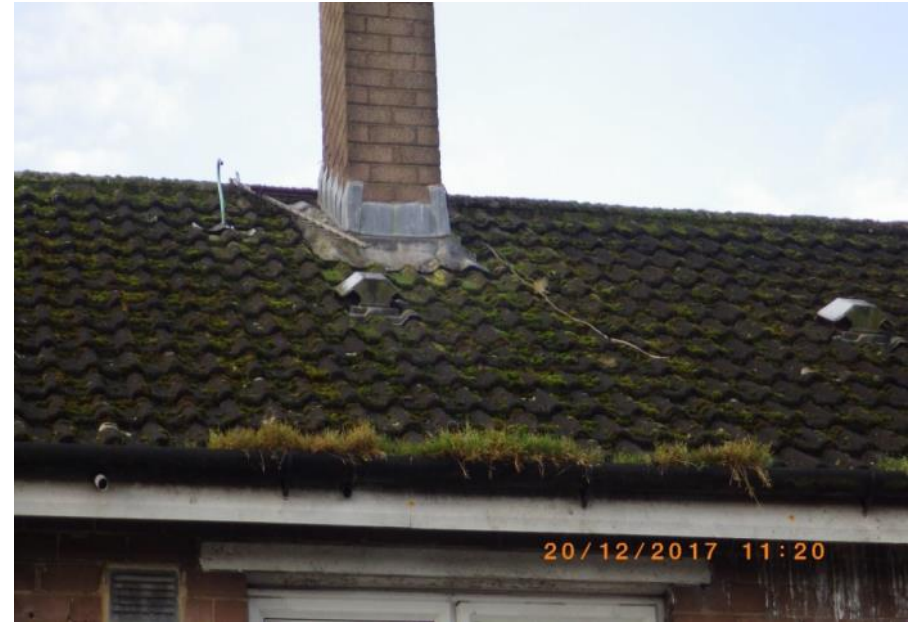
Guttering

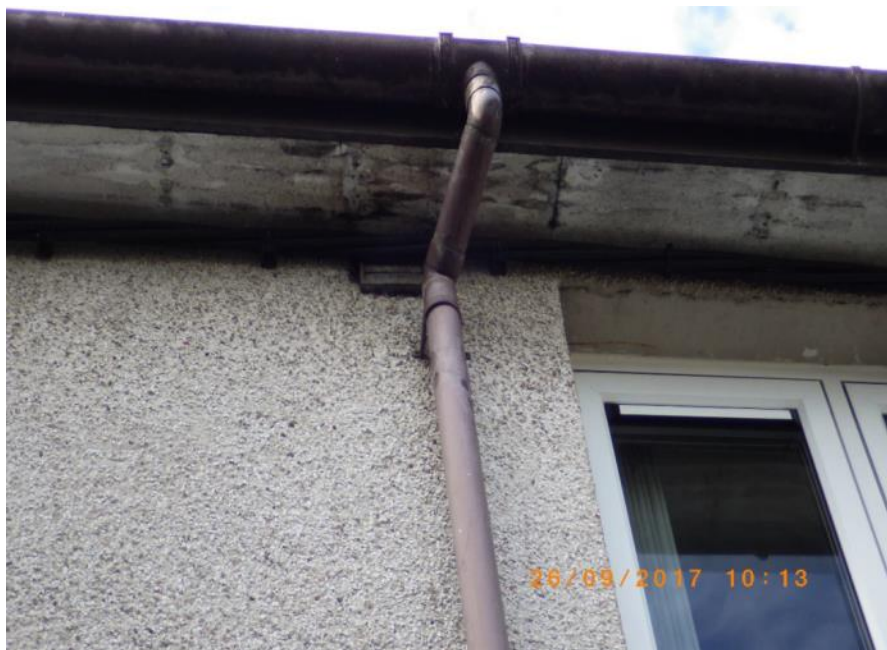
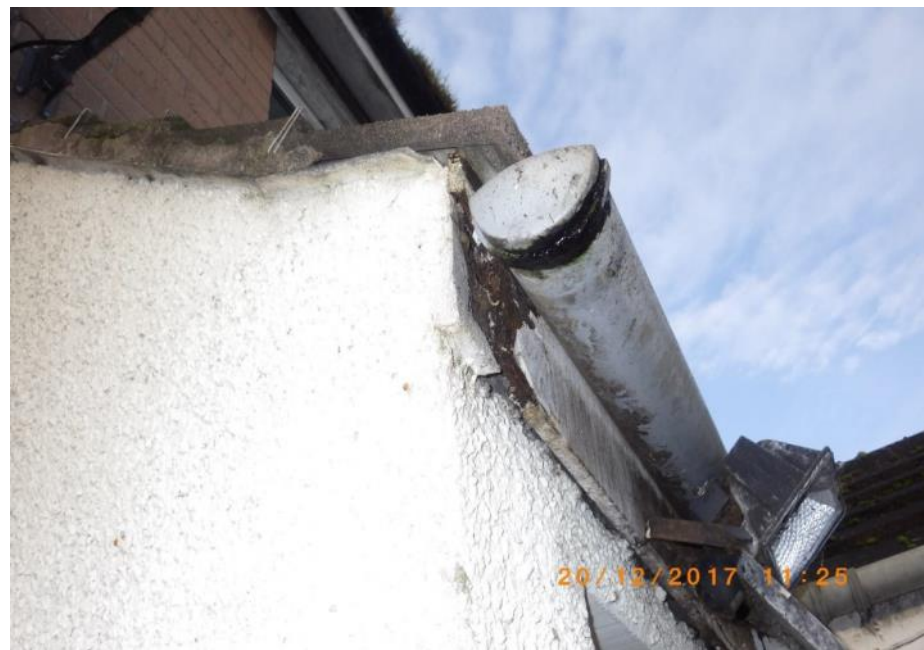
Soffit & Fascia

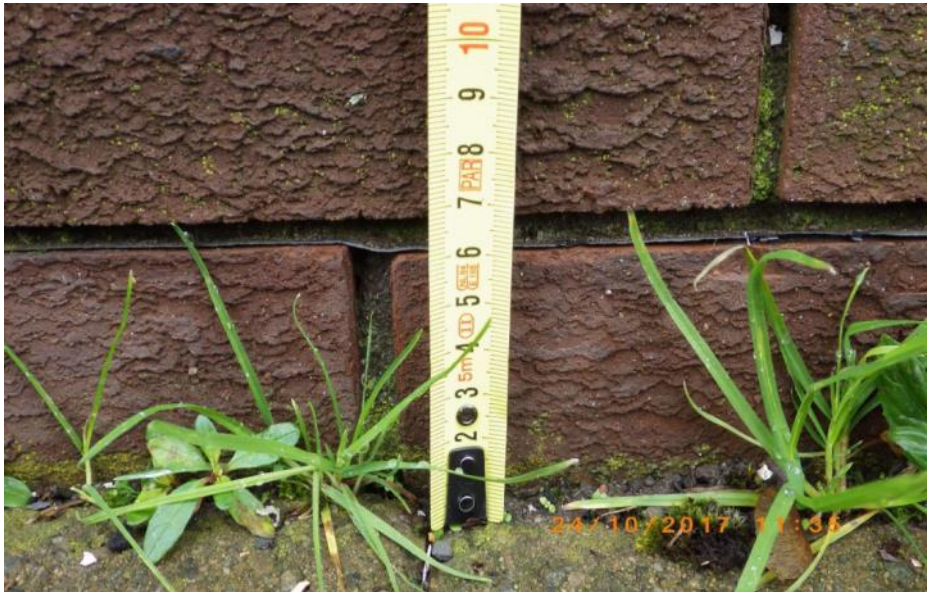
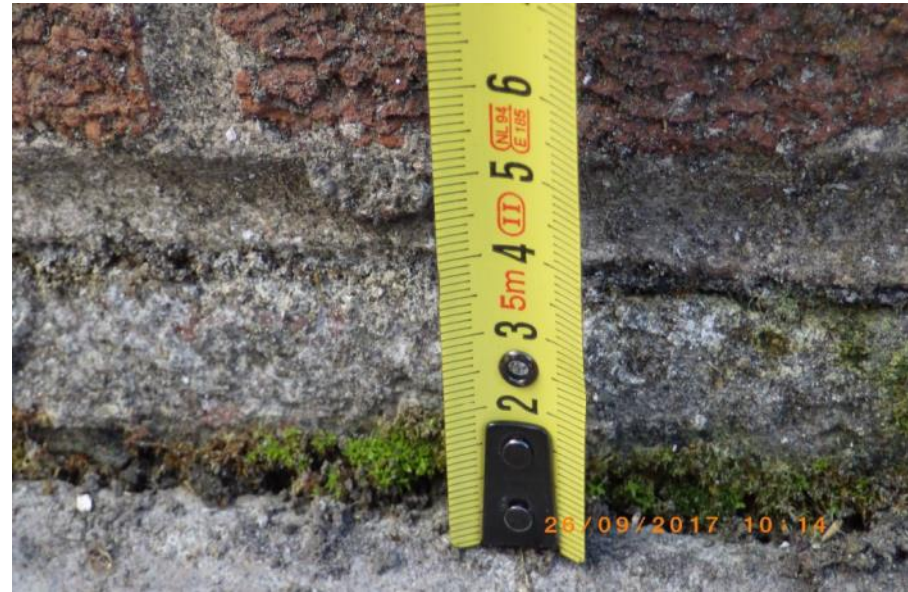
Damp Proof Course (DPC) Level

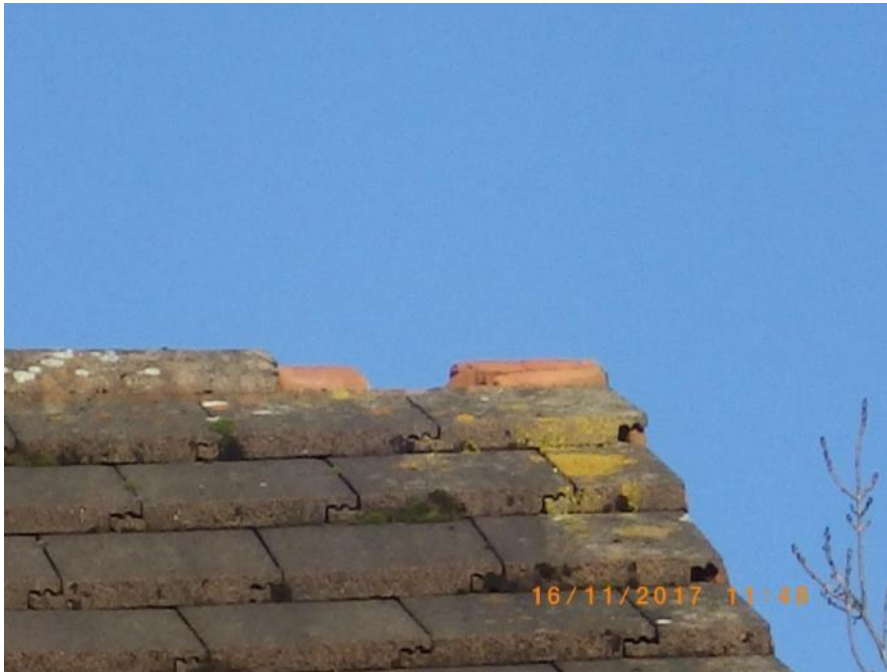
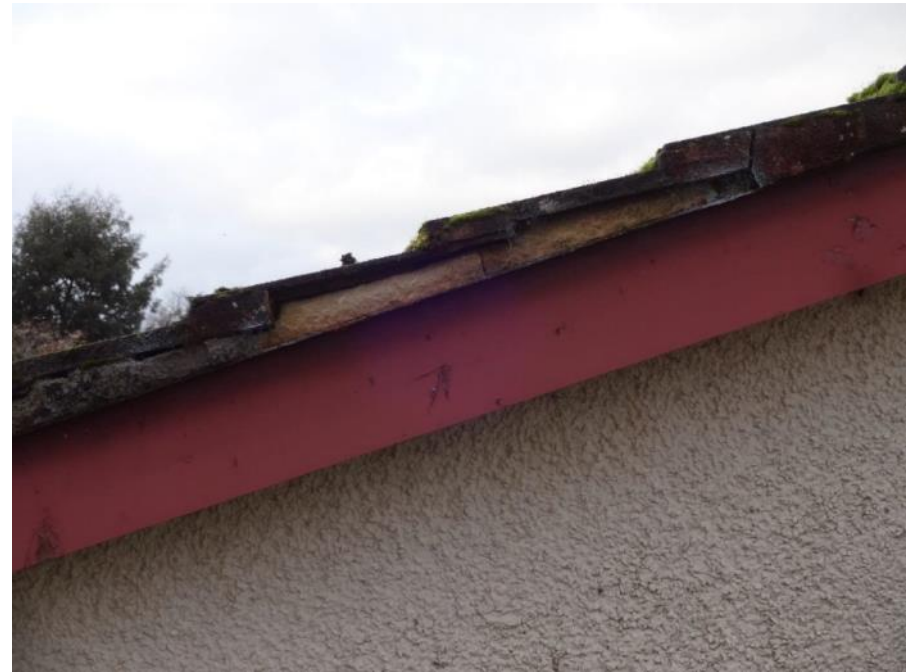
Roof Tiles

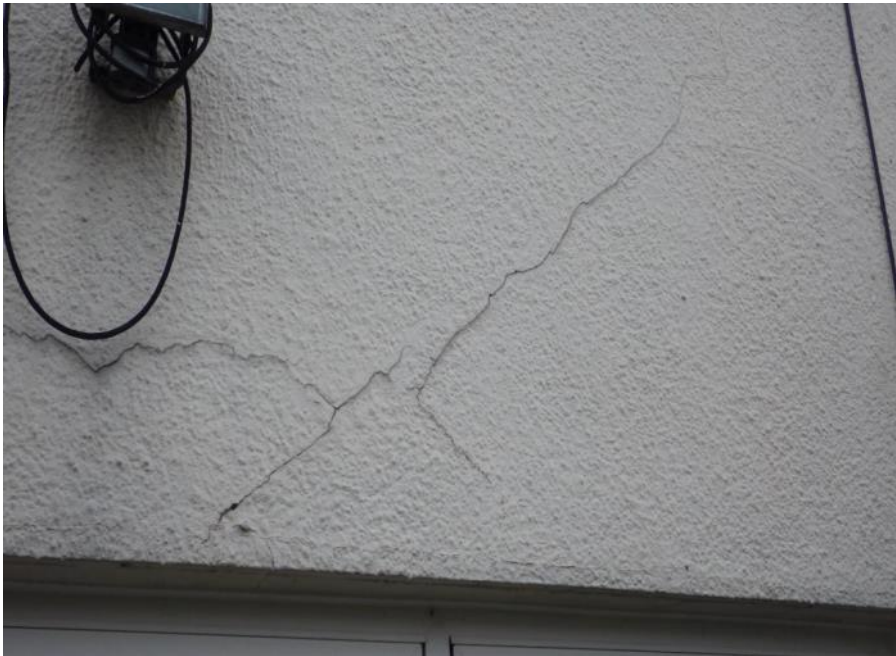
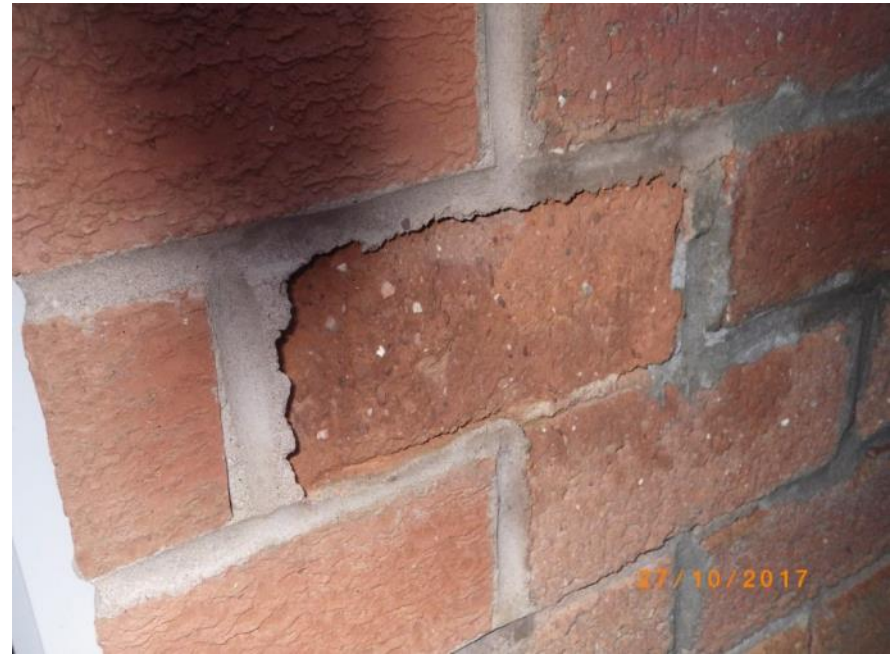
Render & Brickwork

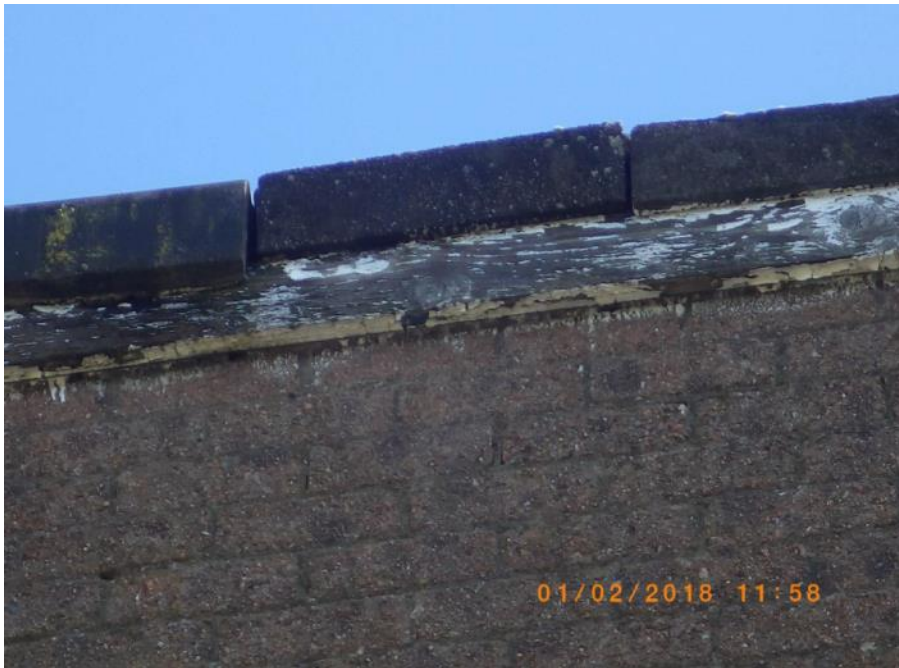
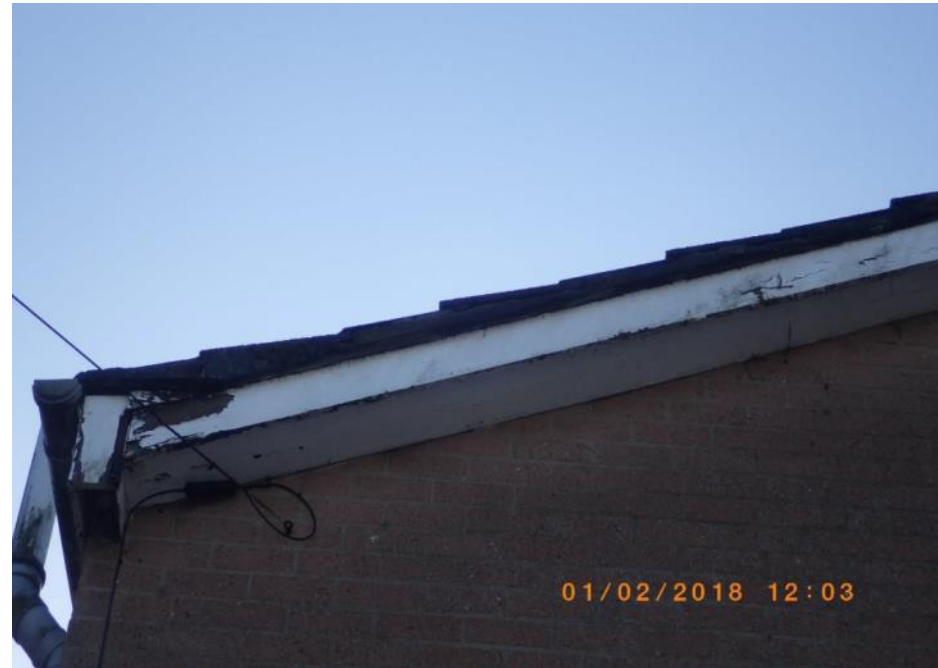
Verge Boards

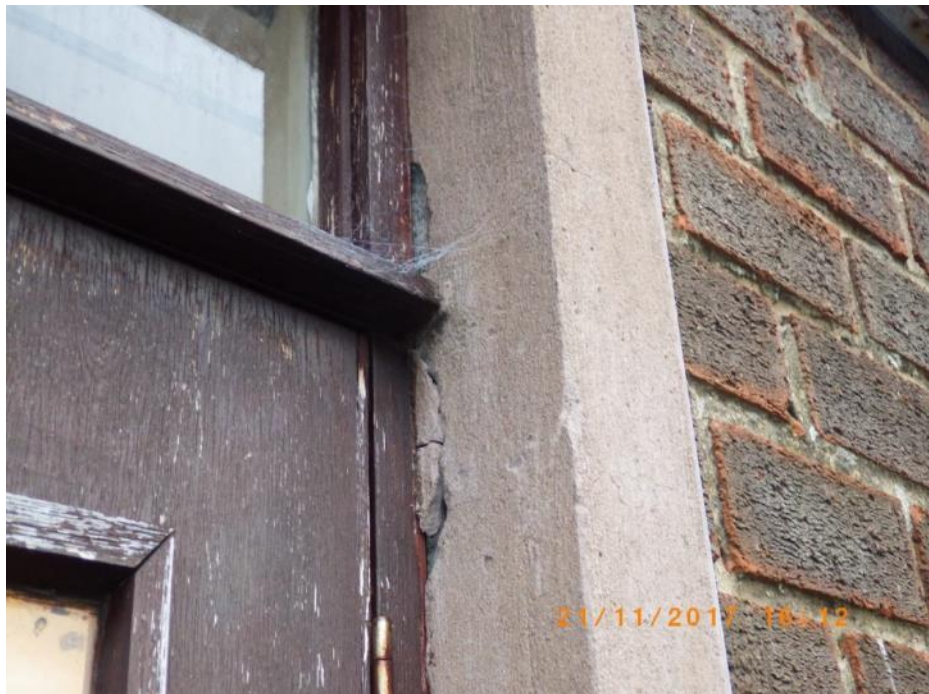
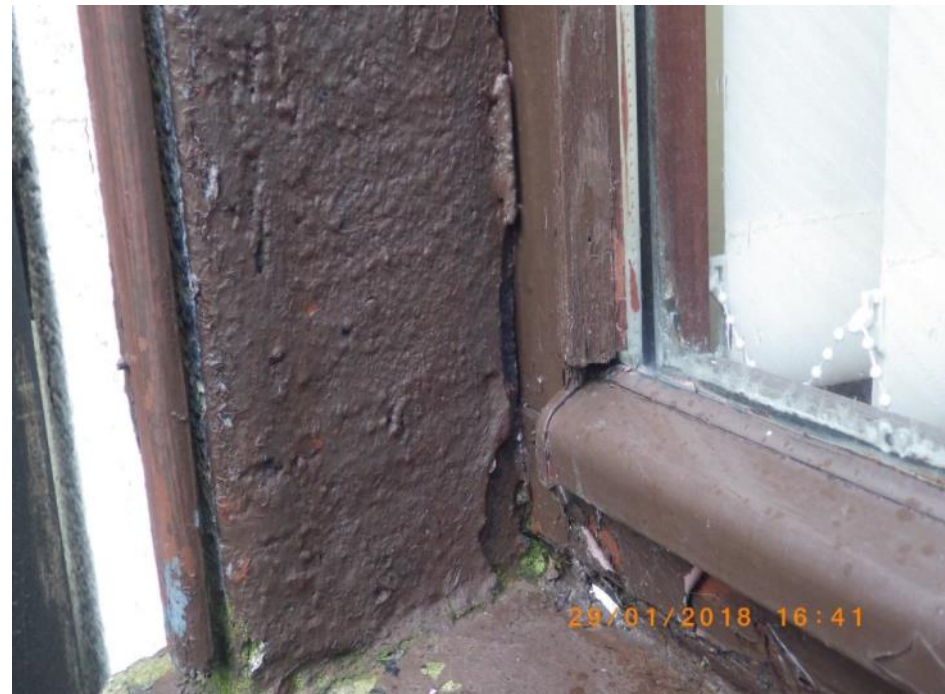
Doors & Window Seals

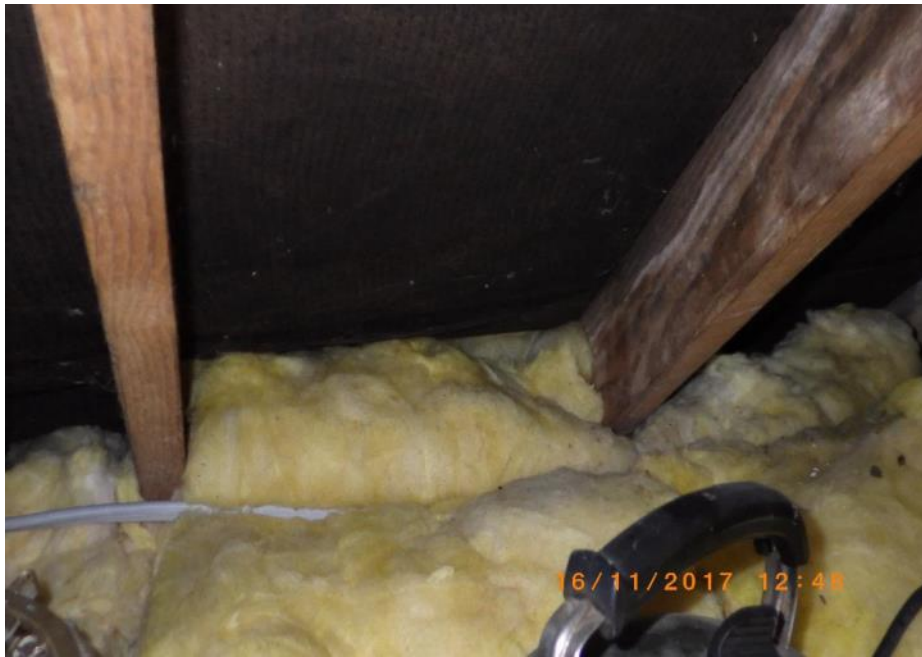
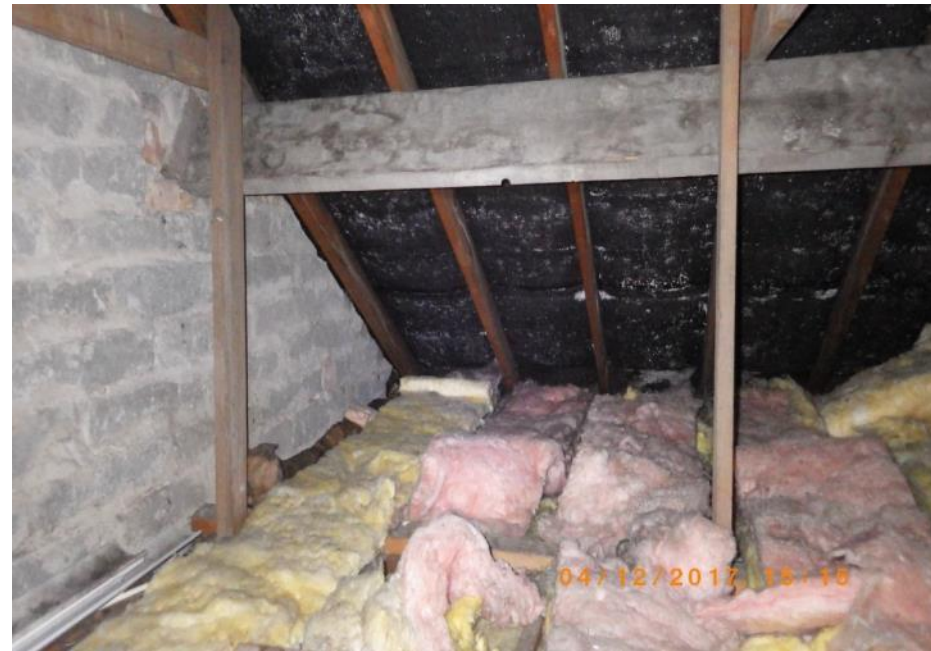
Blocked Eaves
