# Cladding and insulation replacement on multi-storey flats

## Benefits of collaboration between client, contractor and consultants.

In March 2018 Kier Housing Maintenance was contracted by the Hyde Group to remove and replace external cladding and insulation at its 9-storey, mixed tenure Bolanachi Building, Bermondsey while it was fully occupied. It was a constrained site with minimum storage space and flanked by busy roads and a railway line serving central London.

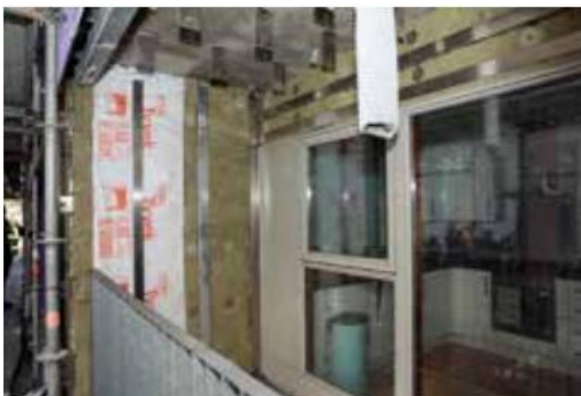
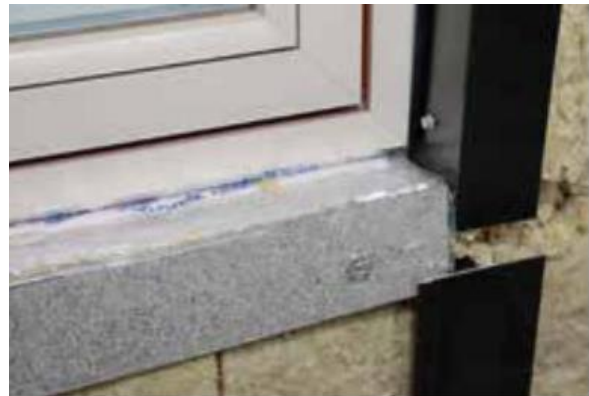
A 5-day removal and replacement sequence devised.

**Day 1:** Existing cladding and other elements stripped back to the Steel Frame Structure (SFS). Existing SFS reviewed to agree any remedial work with client for completion on same day. Insulation installed between metal stud, followed by installation of cement board and waterproof layer.

**Day 2:** Secondary insulation installed, followed by installation of horizontal brackets.

**Day 3:** Fire breaks installed at floor level, party walls and around windows.

**Day 4:** Installation of fire breaks completed and rainscreen insulation installed. Vertical brackets started ready to receive new rainscreen cladding.

**Day 5:** Installation of vertical fire brackets completed and rainscreen cladding installed.
