# Fire Safety: Driving Timber Frame Remediations with Commercial Partners

## **Homes for the South West** Fire Safety Working Group

## Timber frame cavity barrier remedials

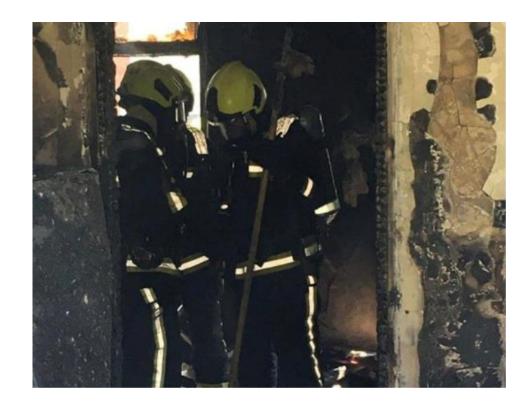
When a timber-framed home in Exeter caught fire in April 2018, it triggered an inquiry that exposed an industry-wide problem.

Investigators established that the fire at the property, which was developed by Persimmon and owned by LiveWest, had begun when a cigarette butt ignited rubbish in a void formed by a subfloor vent below ground level.

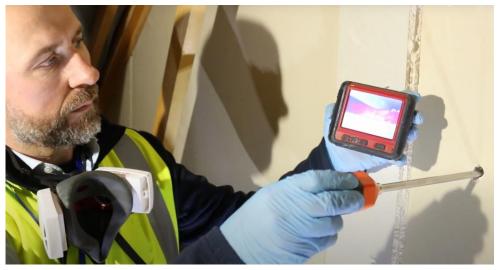
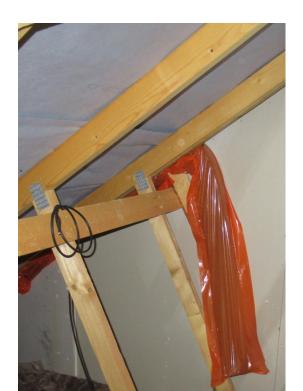
#### **Spandrels and Gables**

- Inspected with a Borescope by drilling a hole and looking up or down the cavity
- Check for plaster board fixings including assessing any cover strips on the panel joints

Check for fire stopping tightly fitted to head of spandrel. NOT like this!

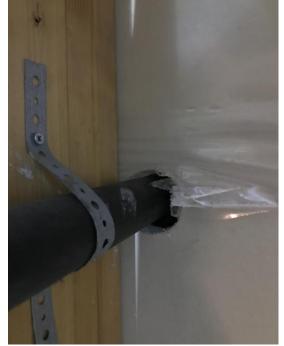
Check to make sure that there is no damage or penetrations through the fire compartment wall. Also note protective polythene has not been removed

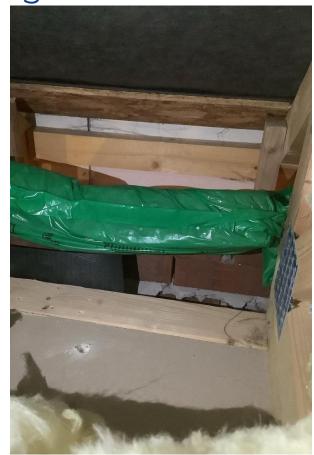
**Eaves** - Inspected with a Borescope by reaching over

and getting a side view down into the cavity

What we should see is a uniform, tightly butted sock in compression.

What we often see is a sock that doesn't fit, has gaps or in some cases isn't even in the cavity!

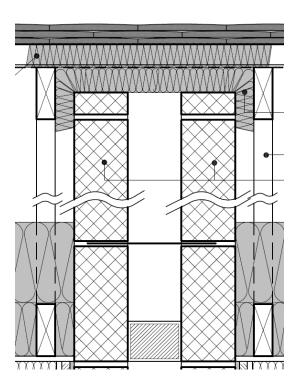
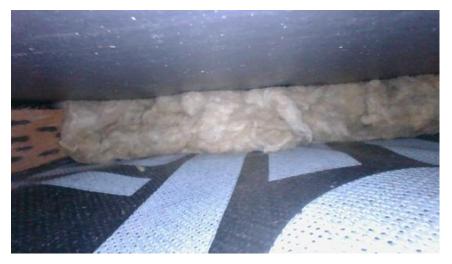
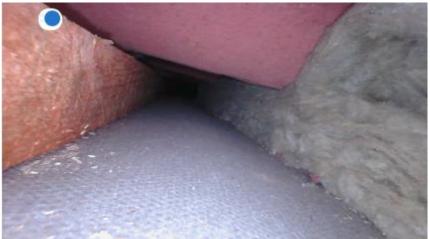
#### Over Felt Fire stopping

Inspected with a Borescope by cutting a hole in the felt and looking sideways.

Should see a full pad of insulation filling the void between the tiles and the felt

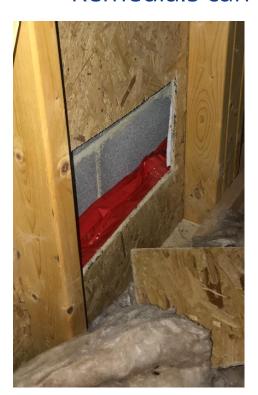
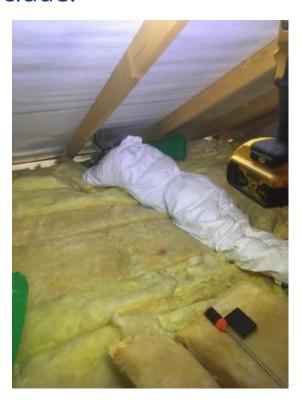
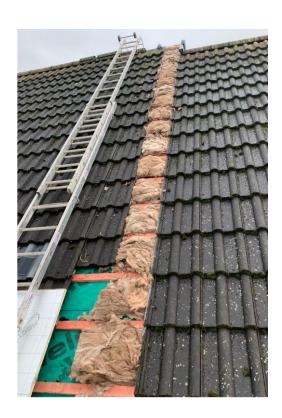
- Taylor Lewis to oversee remedial works with the Developer carrying out the works
- Project Administrators book timeslot with resident
- Inspector oversees all works except for over felt work carried out from scaffold
- Remedials can include:

The membrane is repaired with proprietary tape.

An additional layer of membrane is fixed with batten to ensure water tightness should the tape fail in the long term.

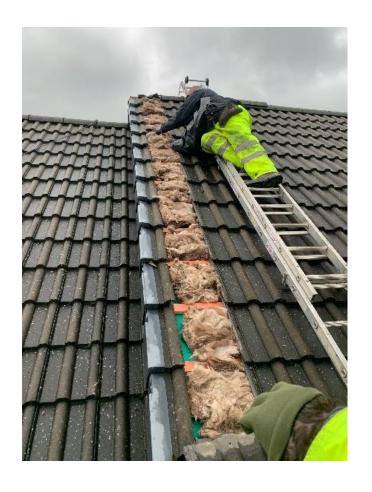
## New methods - over felts

'Traditional' method involves removing slates externally and inserting material between the battens
